Continued Operation of a 25-Raingage Network for Collection, Reduction, and Analysis of Precipitation Data for Lake Michigan Diversion Accounting: Water Year 2014

Nancy E. Westcott

February 2015

FINAL REPORT

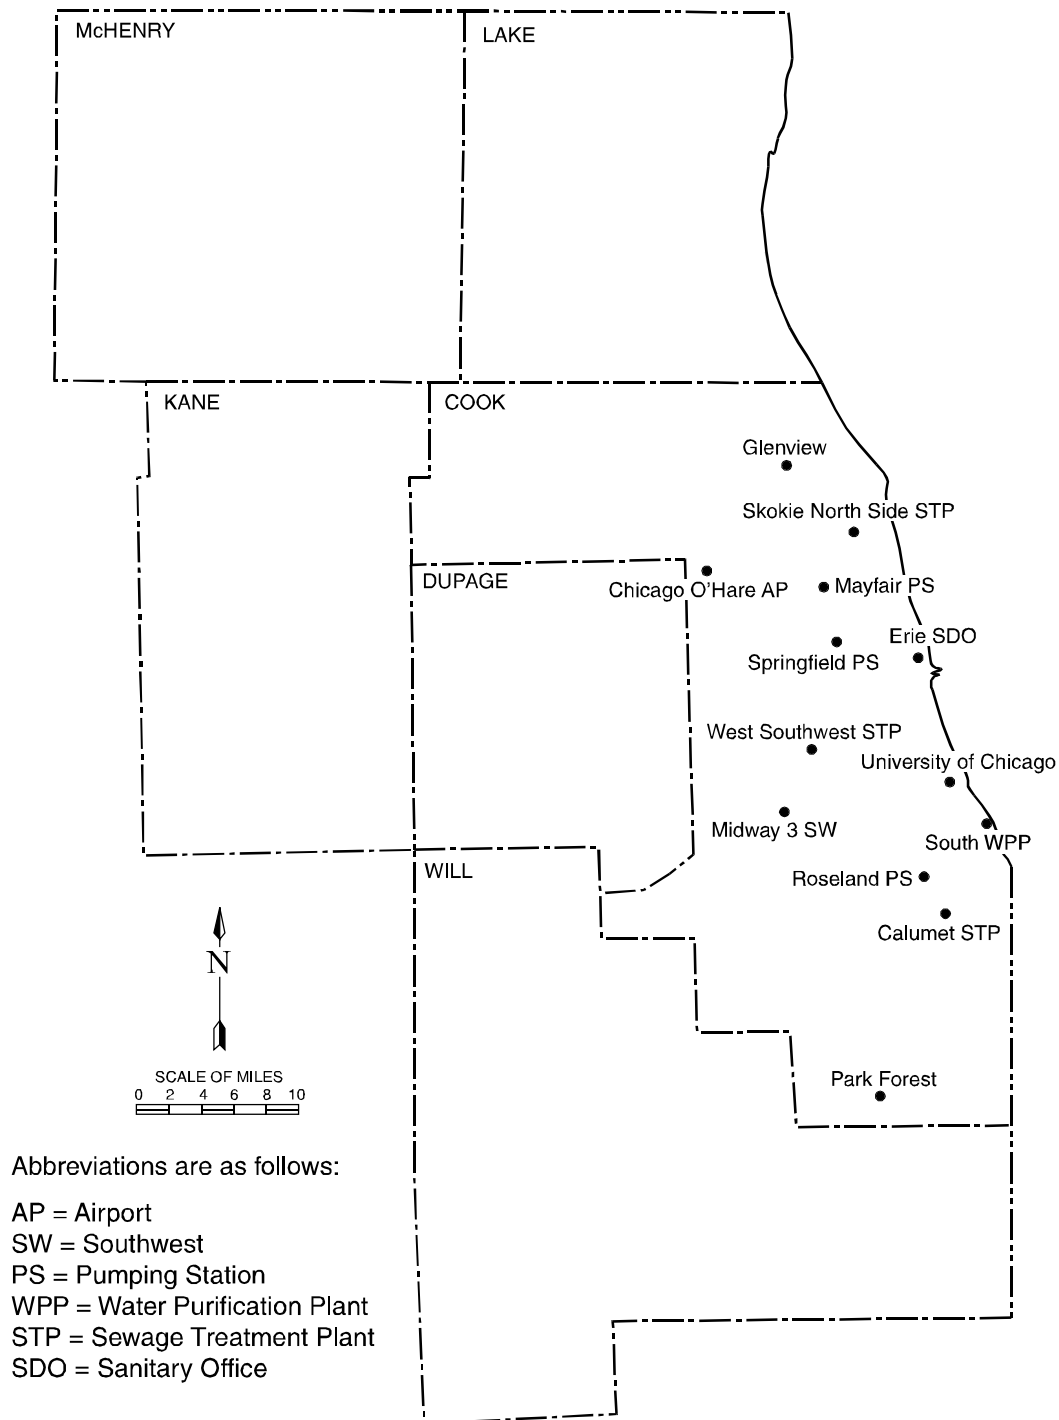
Figure 1. Raingage locations used for diversion accounting purposes prior to Water Year 1990. These include National Weather Service gages located at Chicago O'Hare AP, Midway 3 SW, University of Chicago, and Park Forest; City of Chicago gages located at Mayfair PS, Springfield PS, South WPP, and Roseland PS; and Metropolitan Water Reclamation District of Greater Chicago gages located at Glenview, Skokie North Side STP, Erie SDO, West Southwest STP, and Calumet STP.

The unusual patterns were caused by abnormally low precipitation totals at a select number of the 13 sites used by the accounting procedure (Figure 1). Inspection of these sites (Vogel, 1988), which are irregularly distributed over the region, revealed that low precipitation totals were caused by 1) inadequate gage exposure (e.g., gages situated on rooftops or too near natural or artificial air flow-restricting

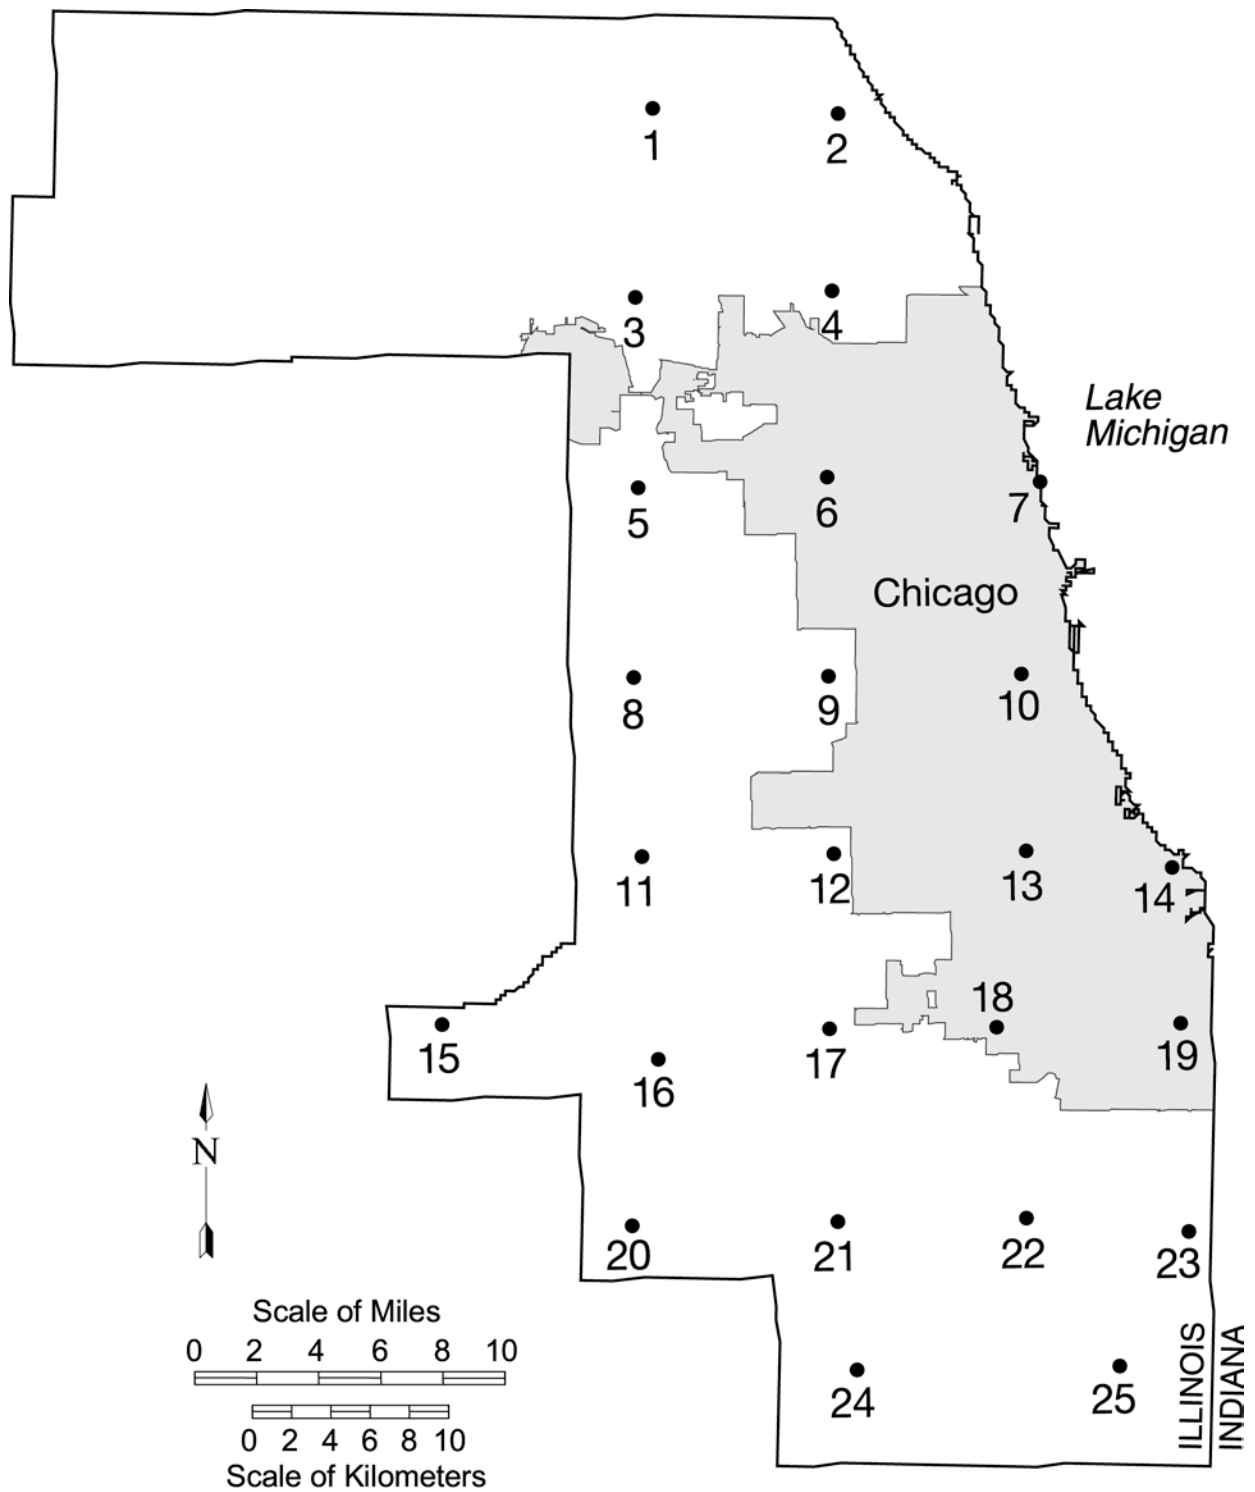
Figure 2. The Cook County 25-site rain gauge network for Water Years 1990-2014. City of Chicago indicated by shading.

The largest precipitation amounts during Water Year 2014 occurred in the central portion of the network (sites #9, #12, #17, #18, and #19, Figure 3). See Figure 2 and Appendix I for site information. The lightest amounts occurred in the northern, western, and near-lake portions of the network (sites #1, #2, #7, #14, and #15). The heaviest precipitation in the network during Water Year 2014 fell at site #12 (48.07 inches), while the lightest fell at site #2 (32.55 inches).

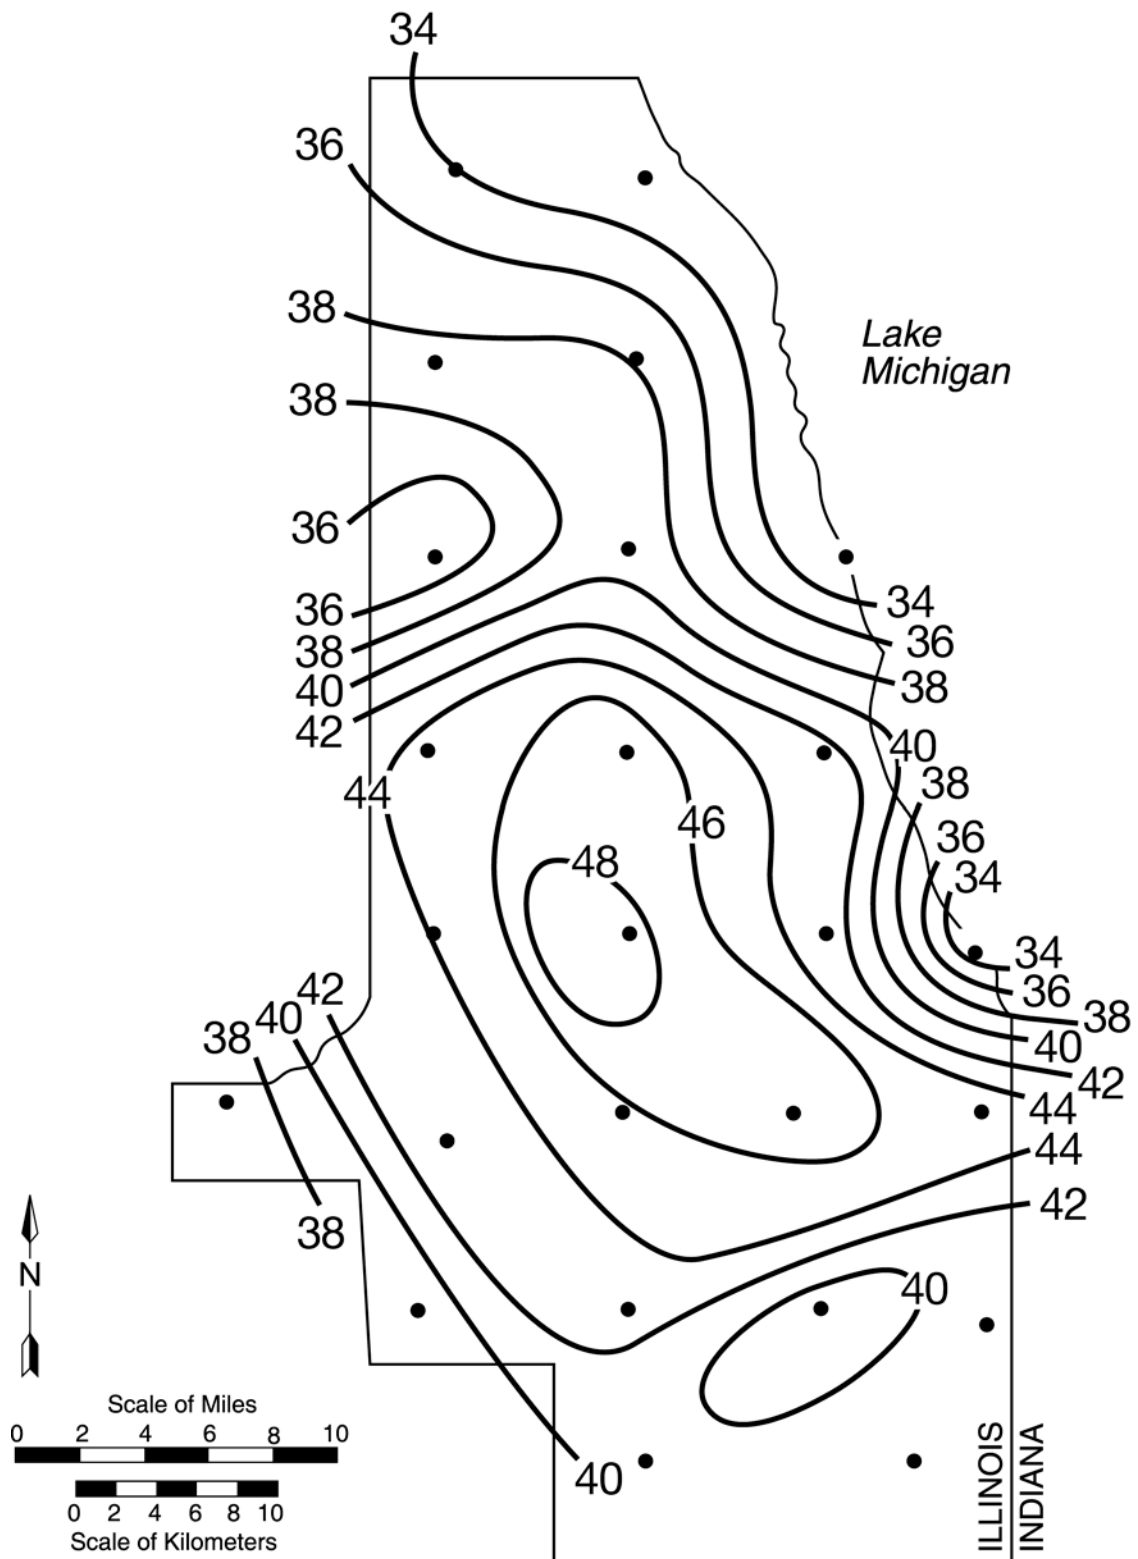
Figure 3. Precipitation pattern (inches) for Water Year 2014

As in the case of the other network water year patterns, the spatial pattern for Water Year 2014 (Figure 3) does not contain the anomalies found in an analysis using sites operated by the MWRDGC, the NWS, and Cook County for Water Years 1984–1989 (Vogel, 1988; Peppler, 1993b). Gradients of 15 to 20 inches were common in those analyses. Precipitation data from those sites were the input for diversion accounting before construction of the present network (Peppler, 1993b). For Water Year 2014, there were 9-inch gradients between Sites #7 and #10 and between #13 and #1, and an 11-inch gradient between #14 and #19. Lower values may be due to storm location or siting issues. Site #14 is in a very windy location, but has an Alter shield to help reduce wind loss. Site #2 was moved downhill in June 2014 to a less windy location. These siting differences may accentuate actual precipitation gradients suggested by nearby gages.

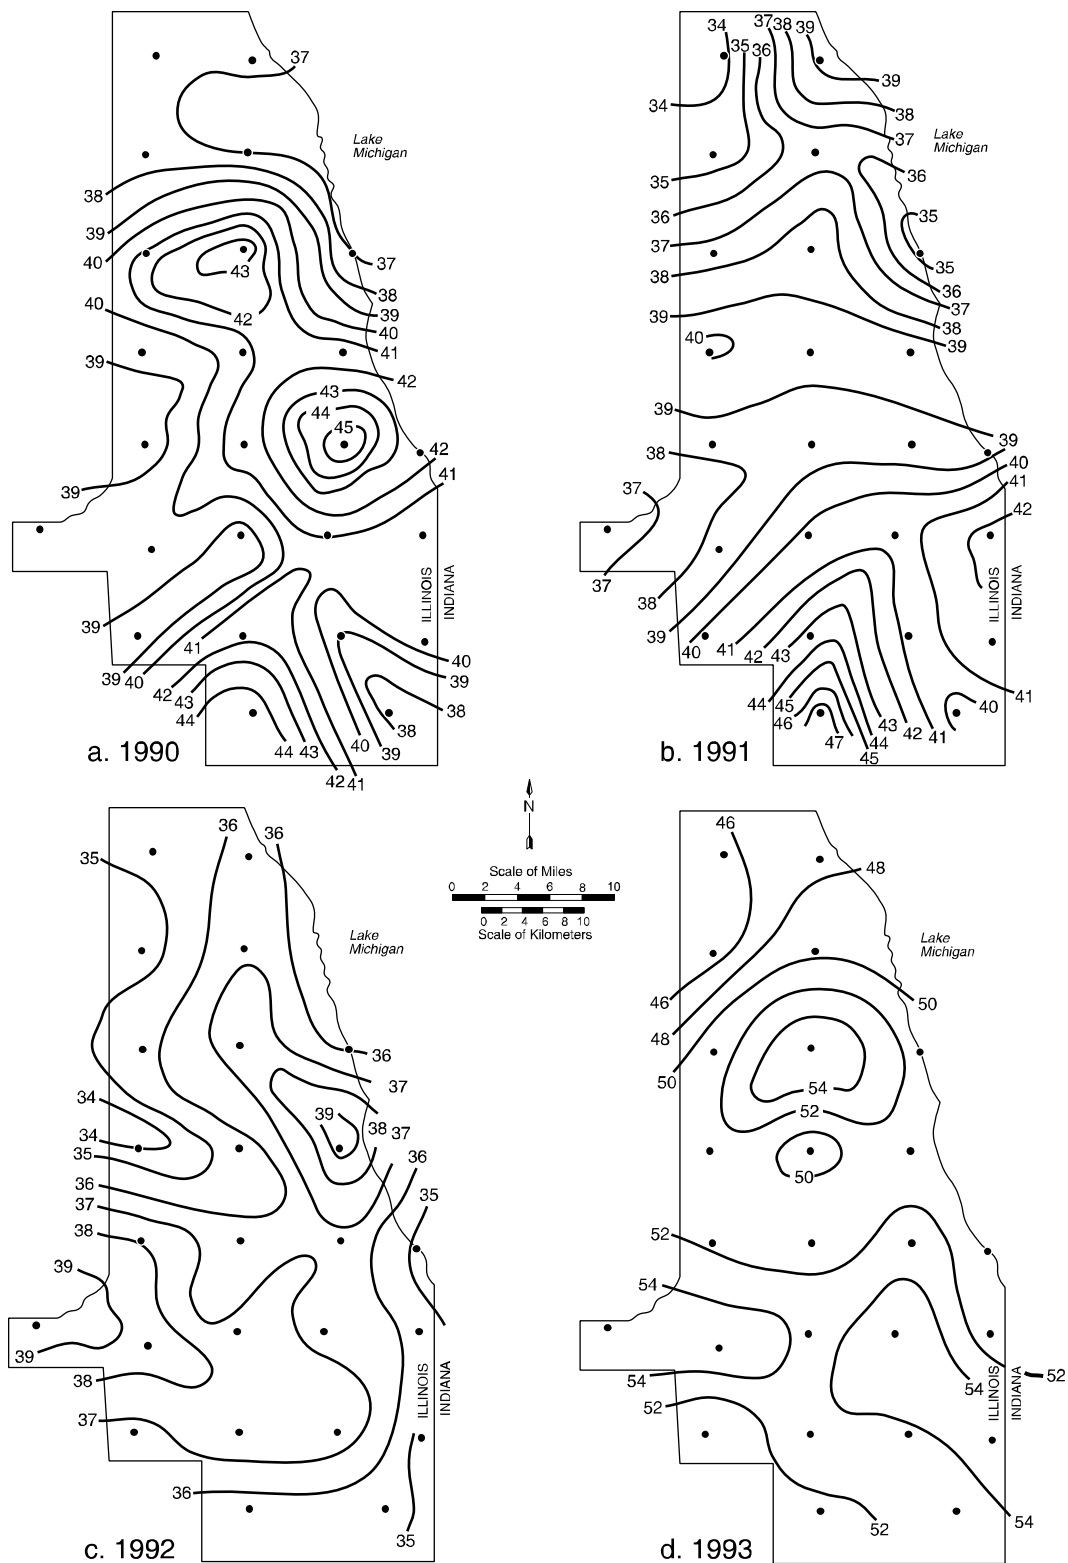
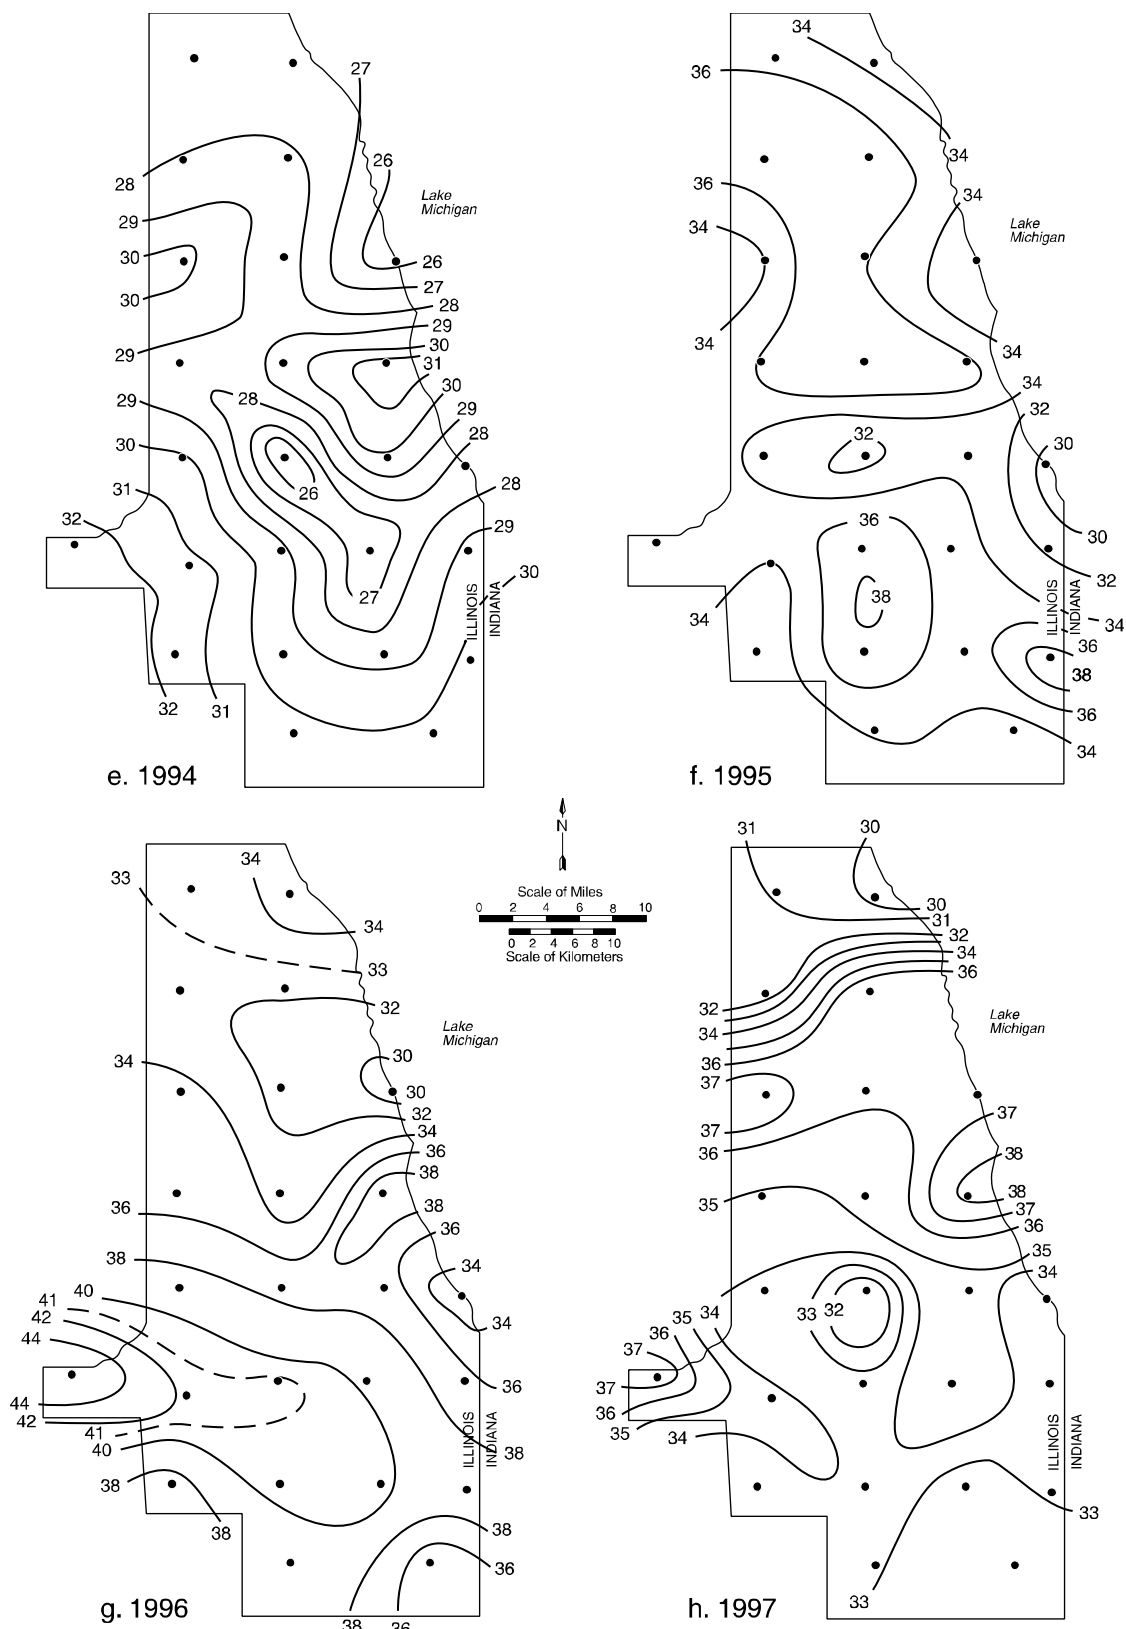
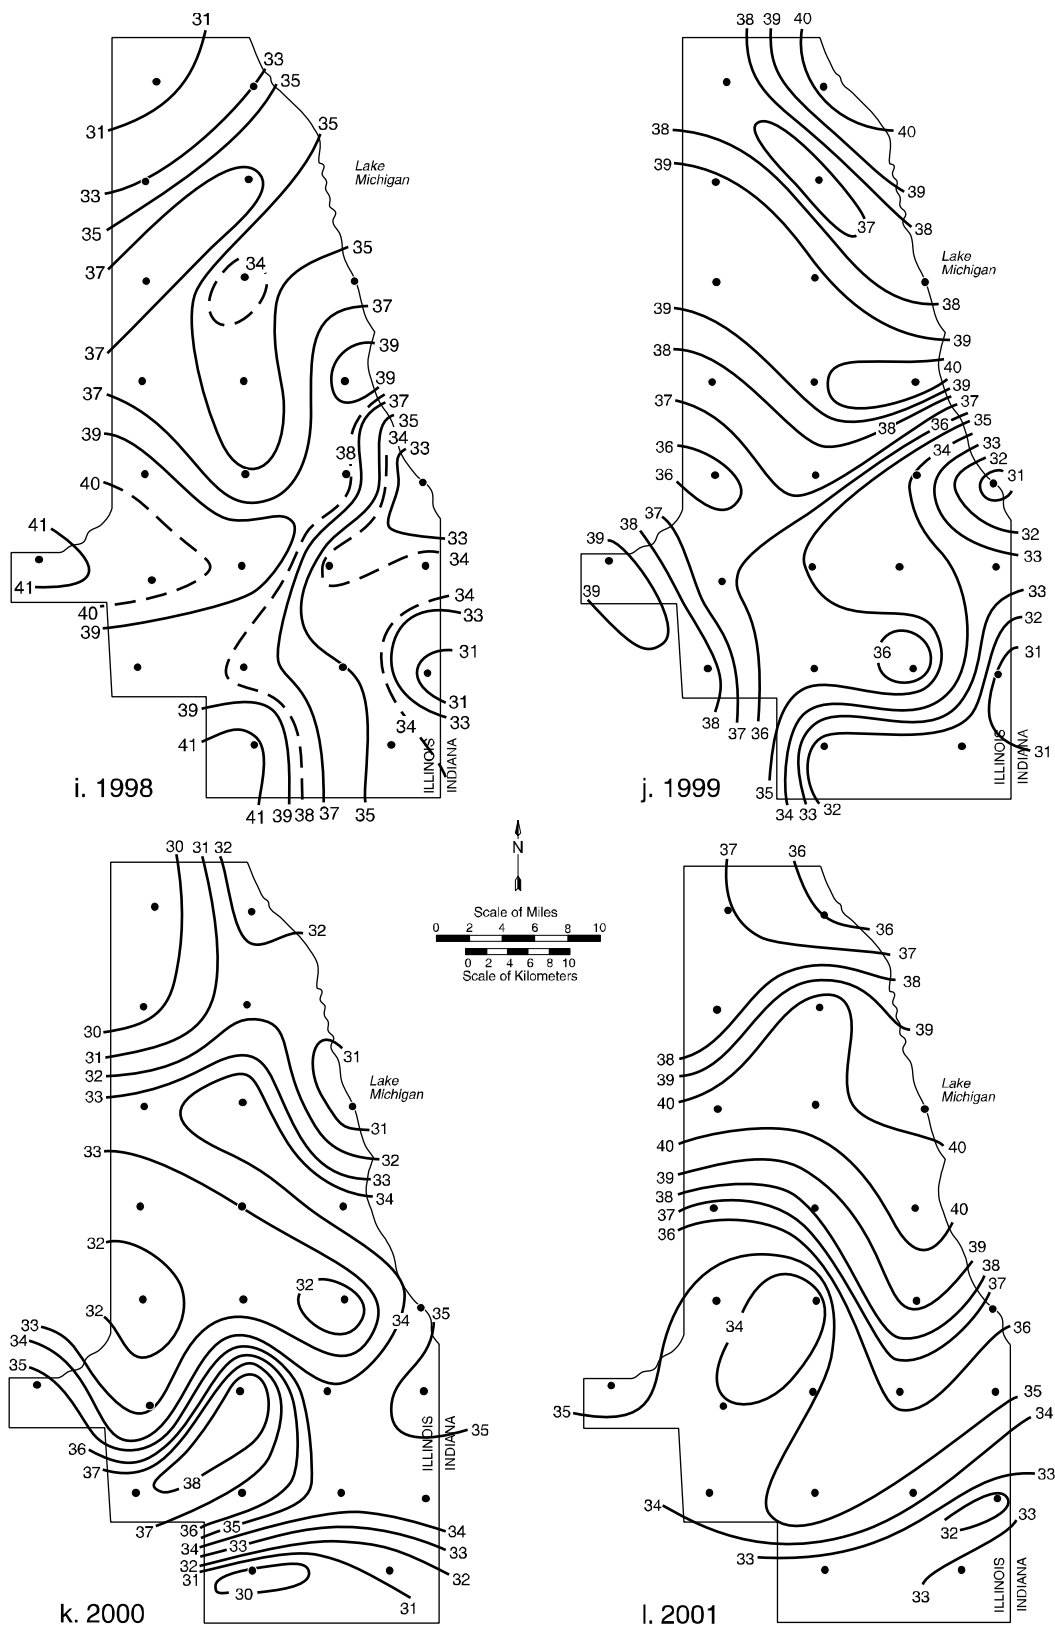
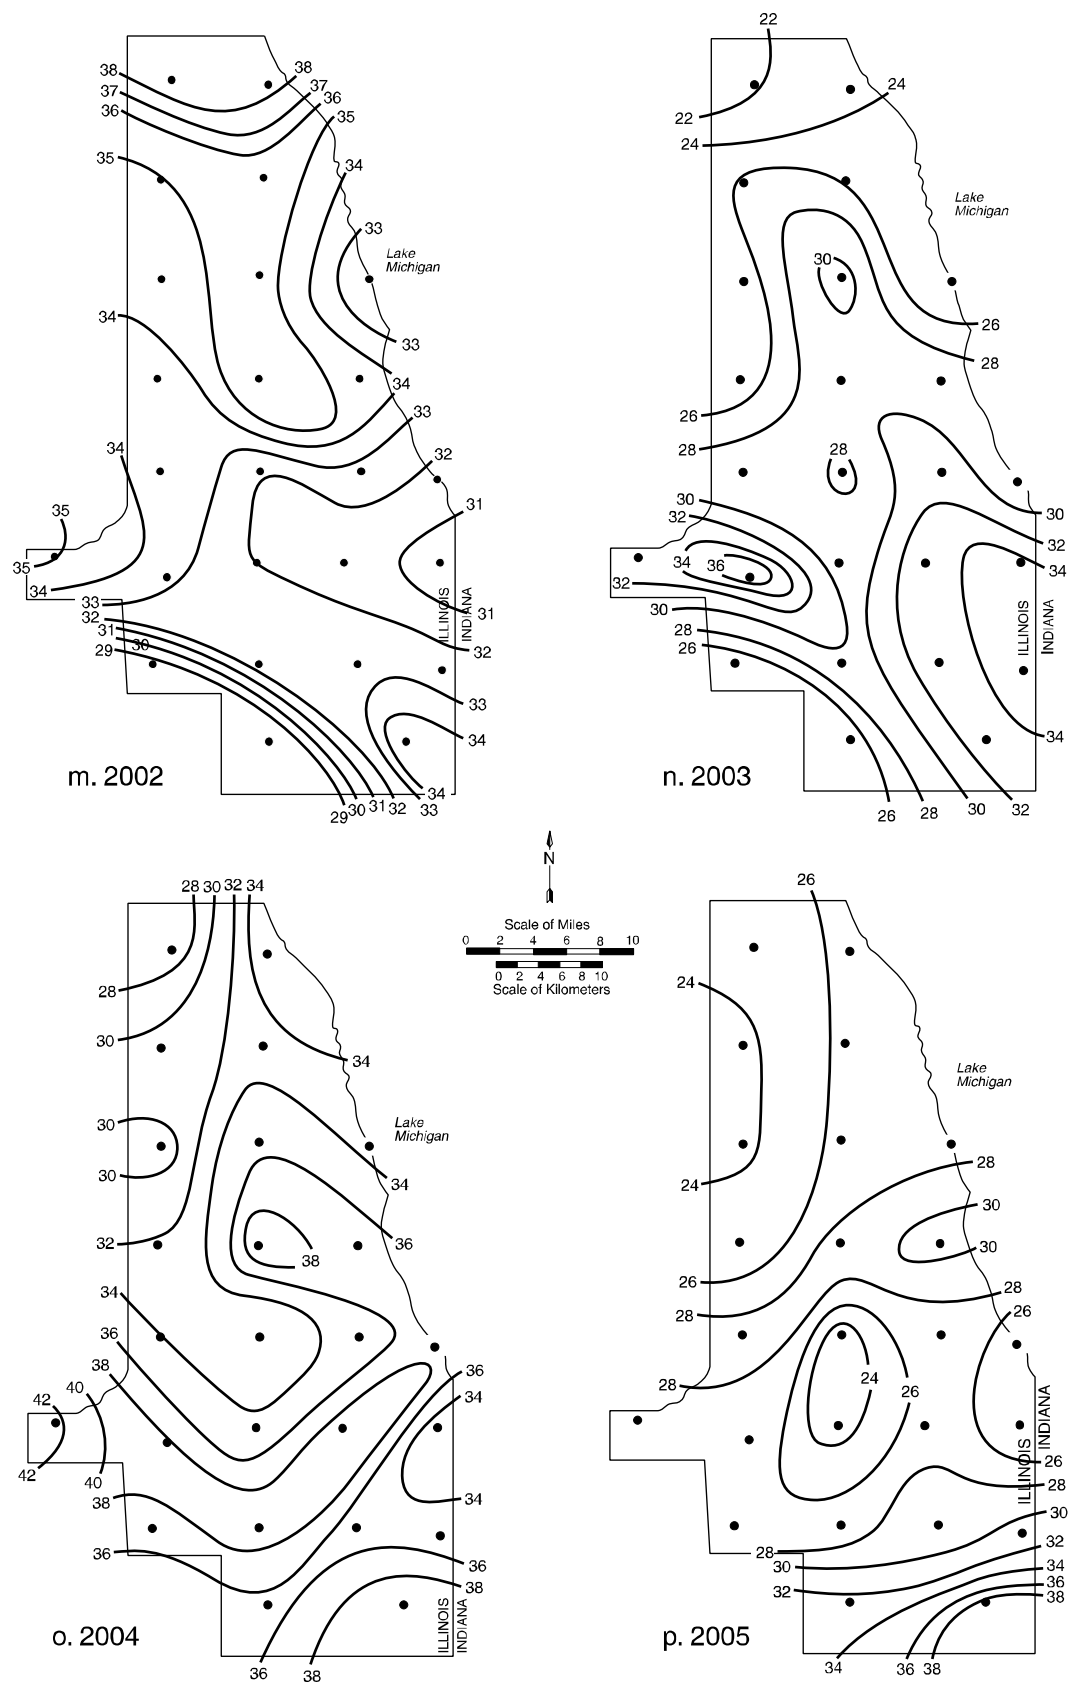
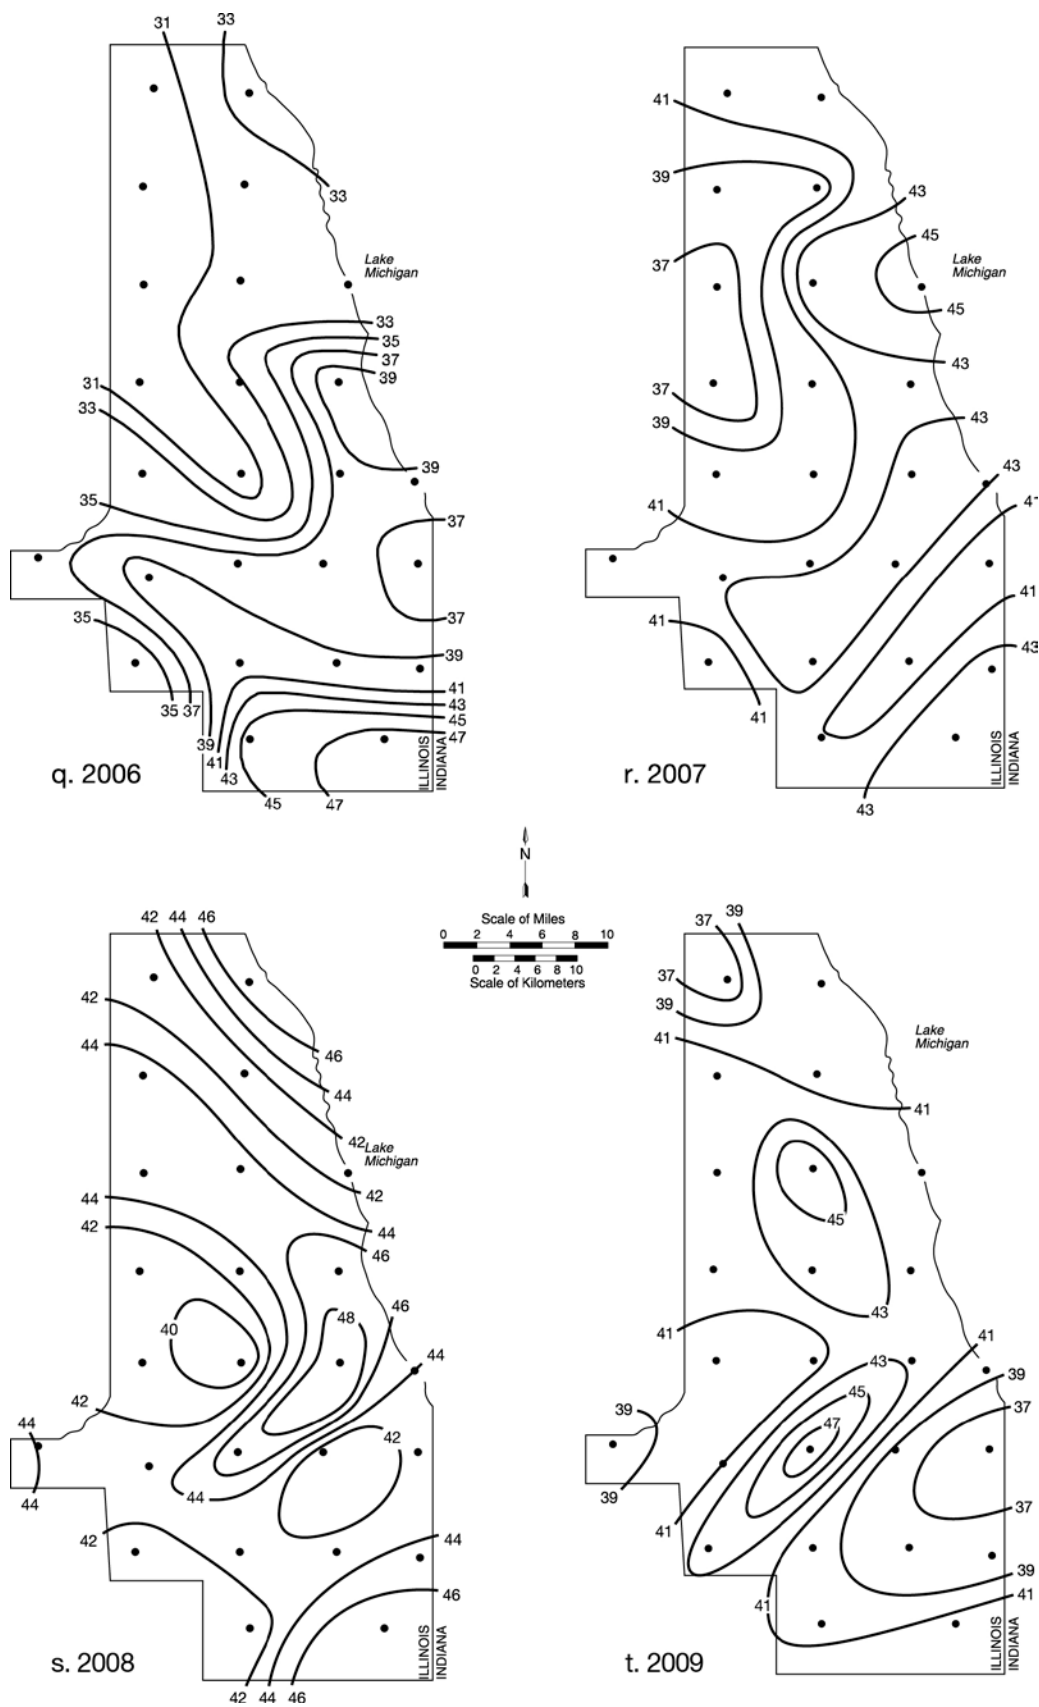
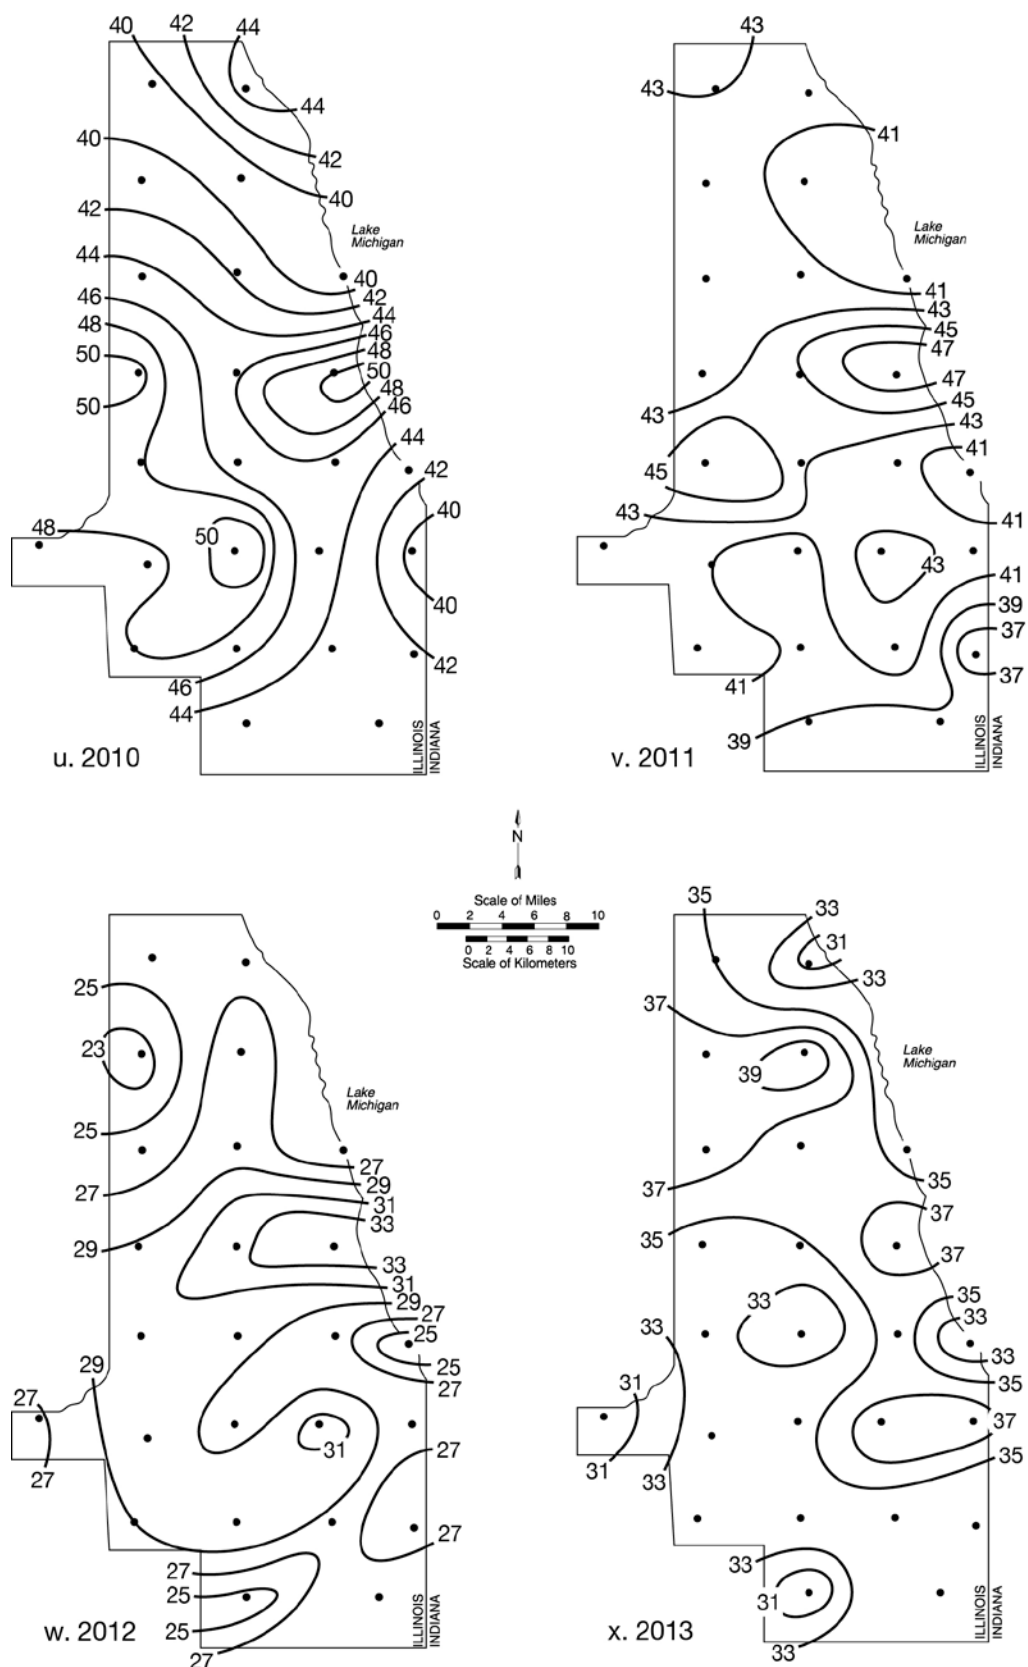
Figure 4. Precipitation pattern (inches) for Water Years 1990–2013

Figure 4 provides maps of precipitation amounts for individual Water Years 1990–2013. The general pattern of high values for Water Year 2014 is similar to that for Water Year 1990, 1992, and 2012, with the largest precipitation in the central region and the lowest precipitation along the lake shore.

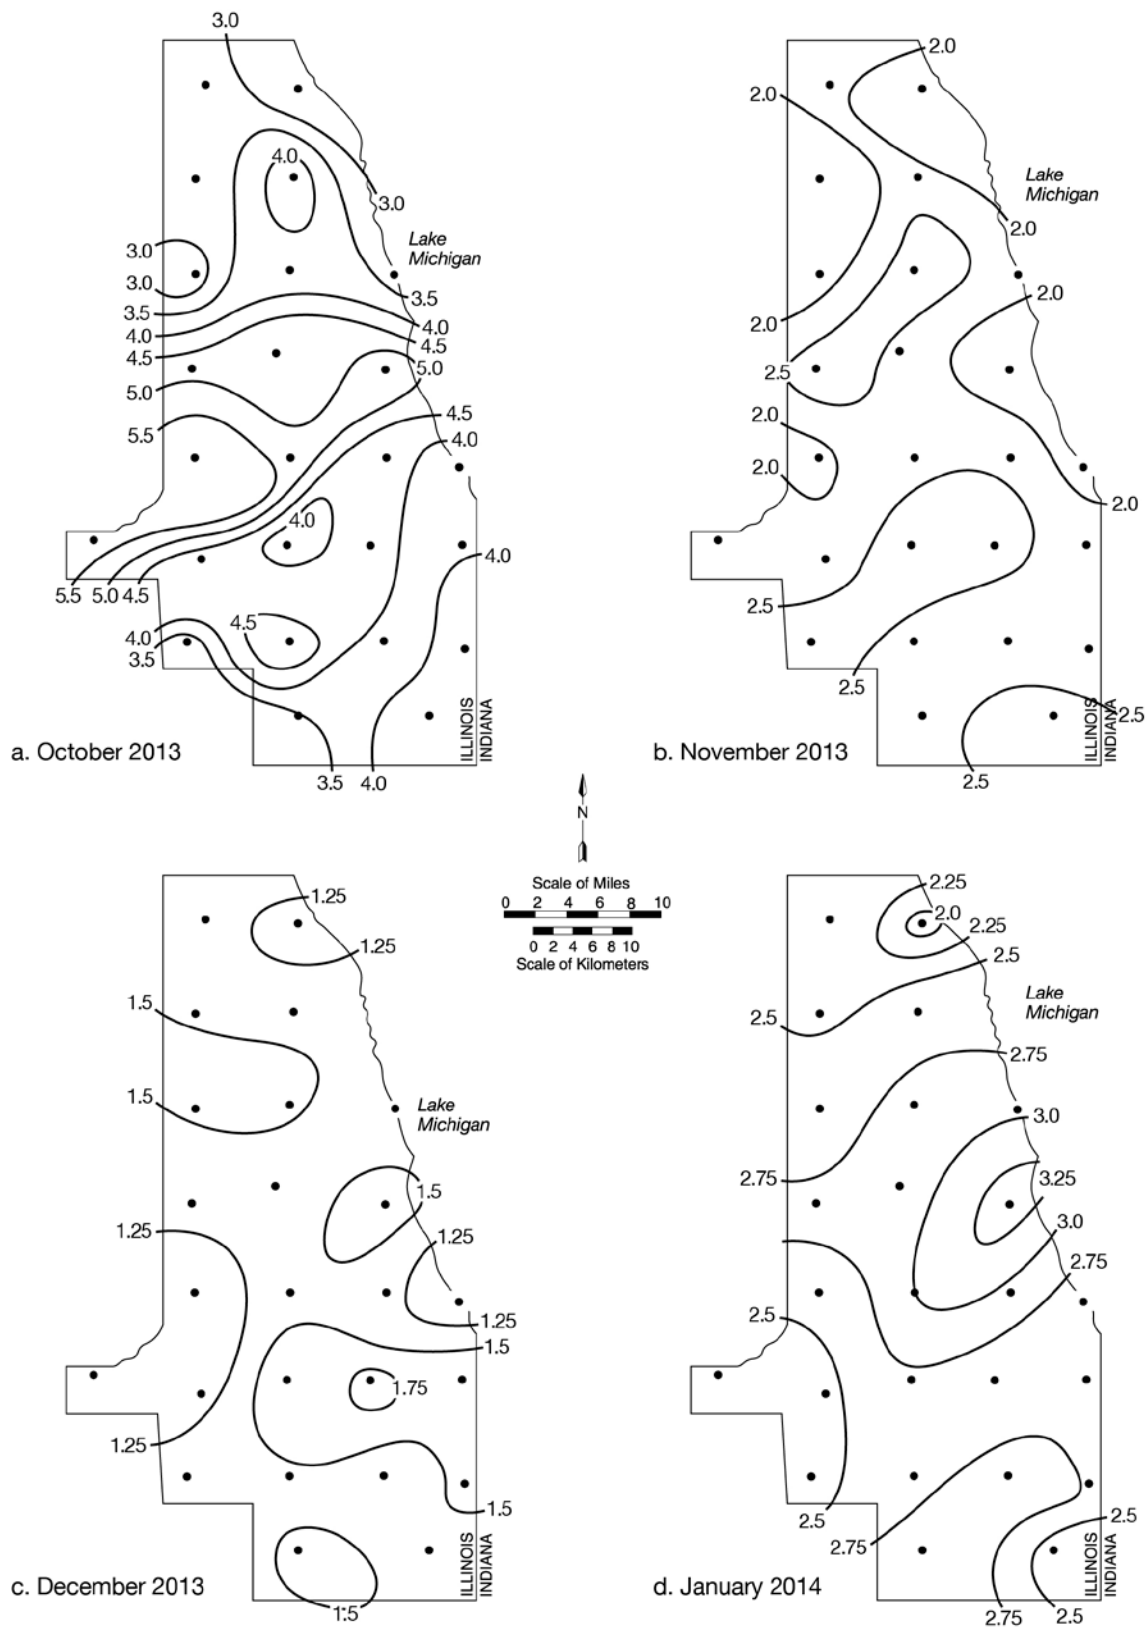
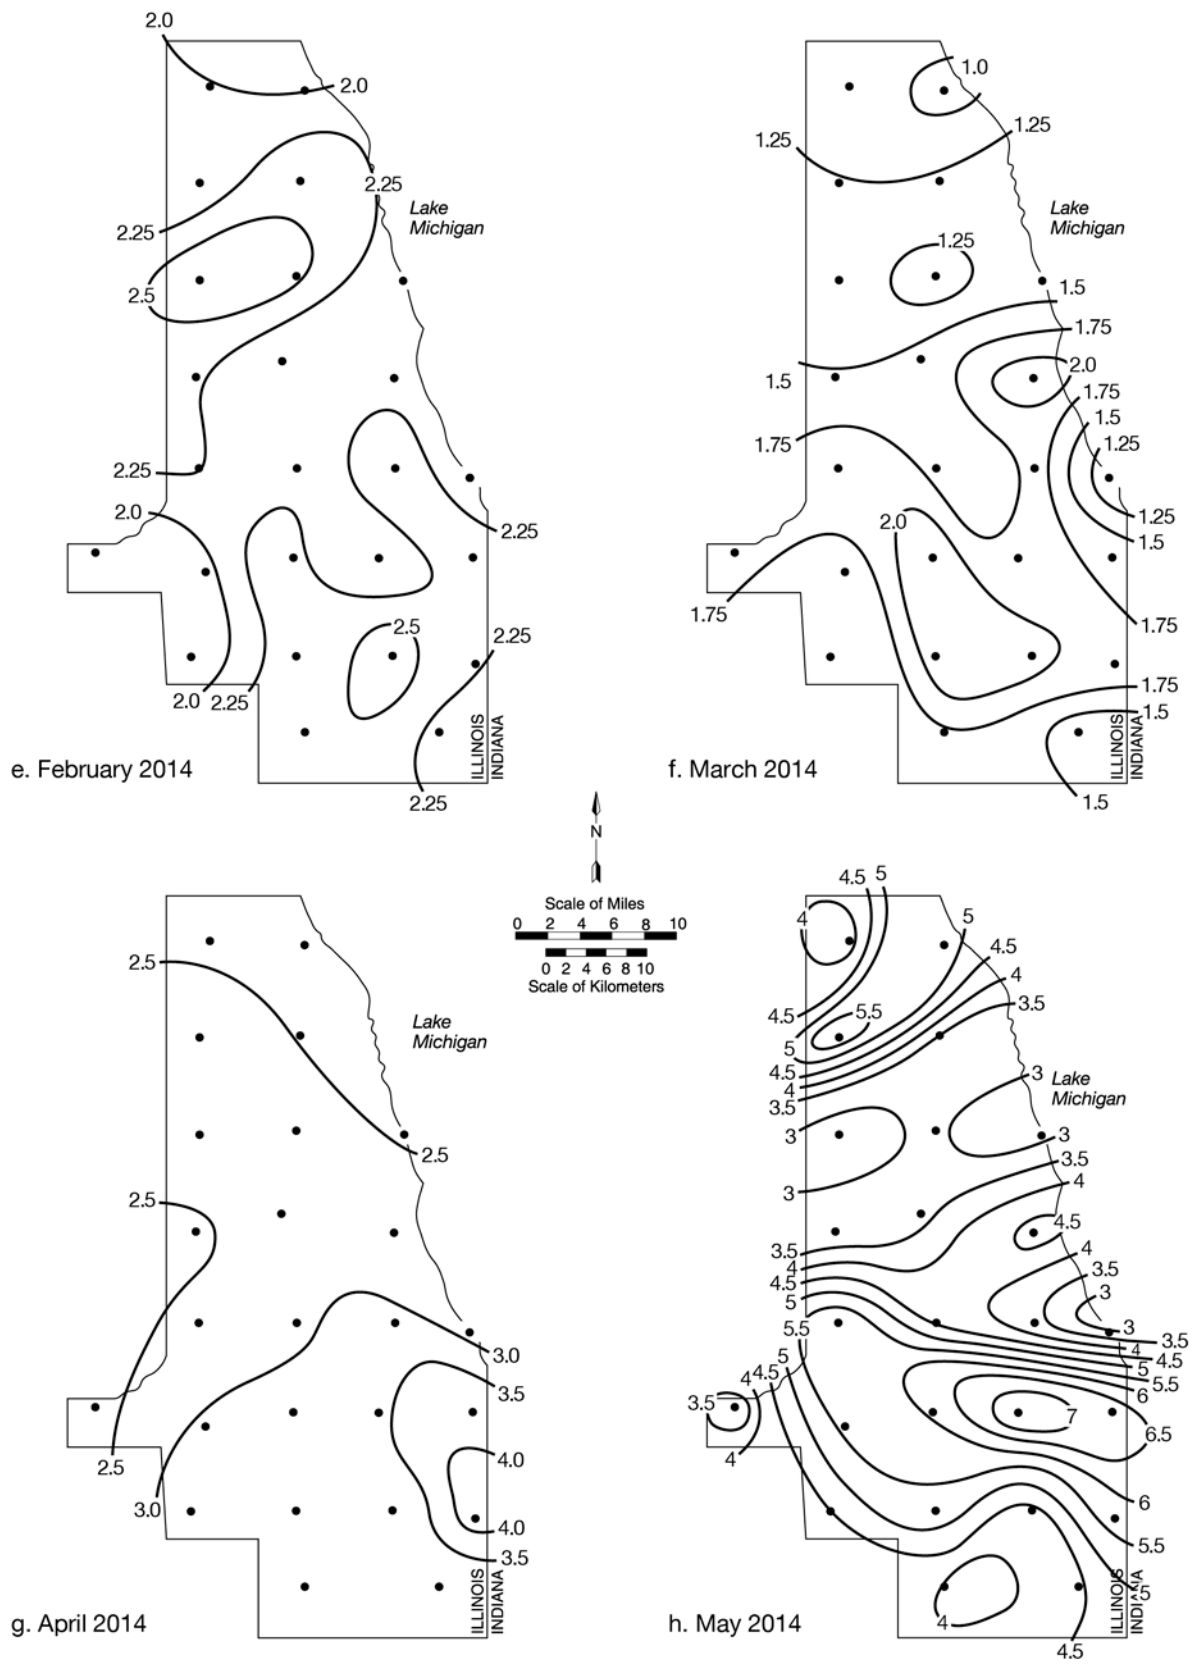
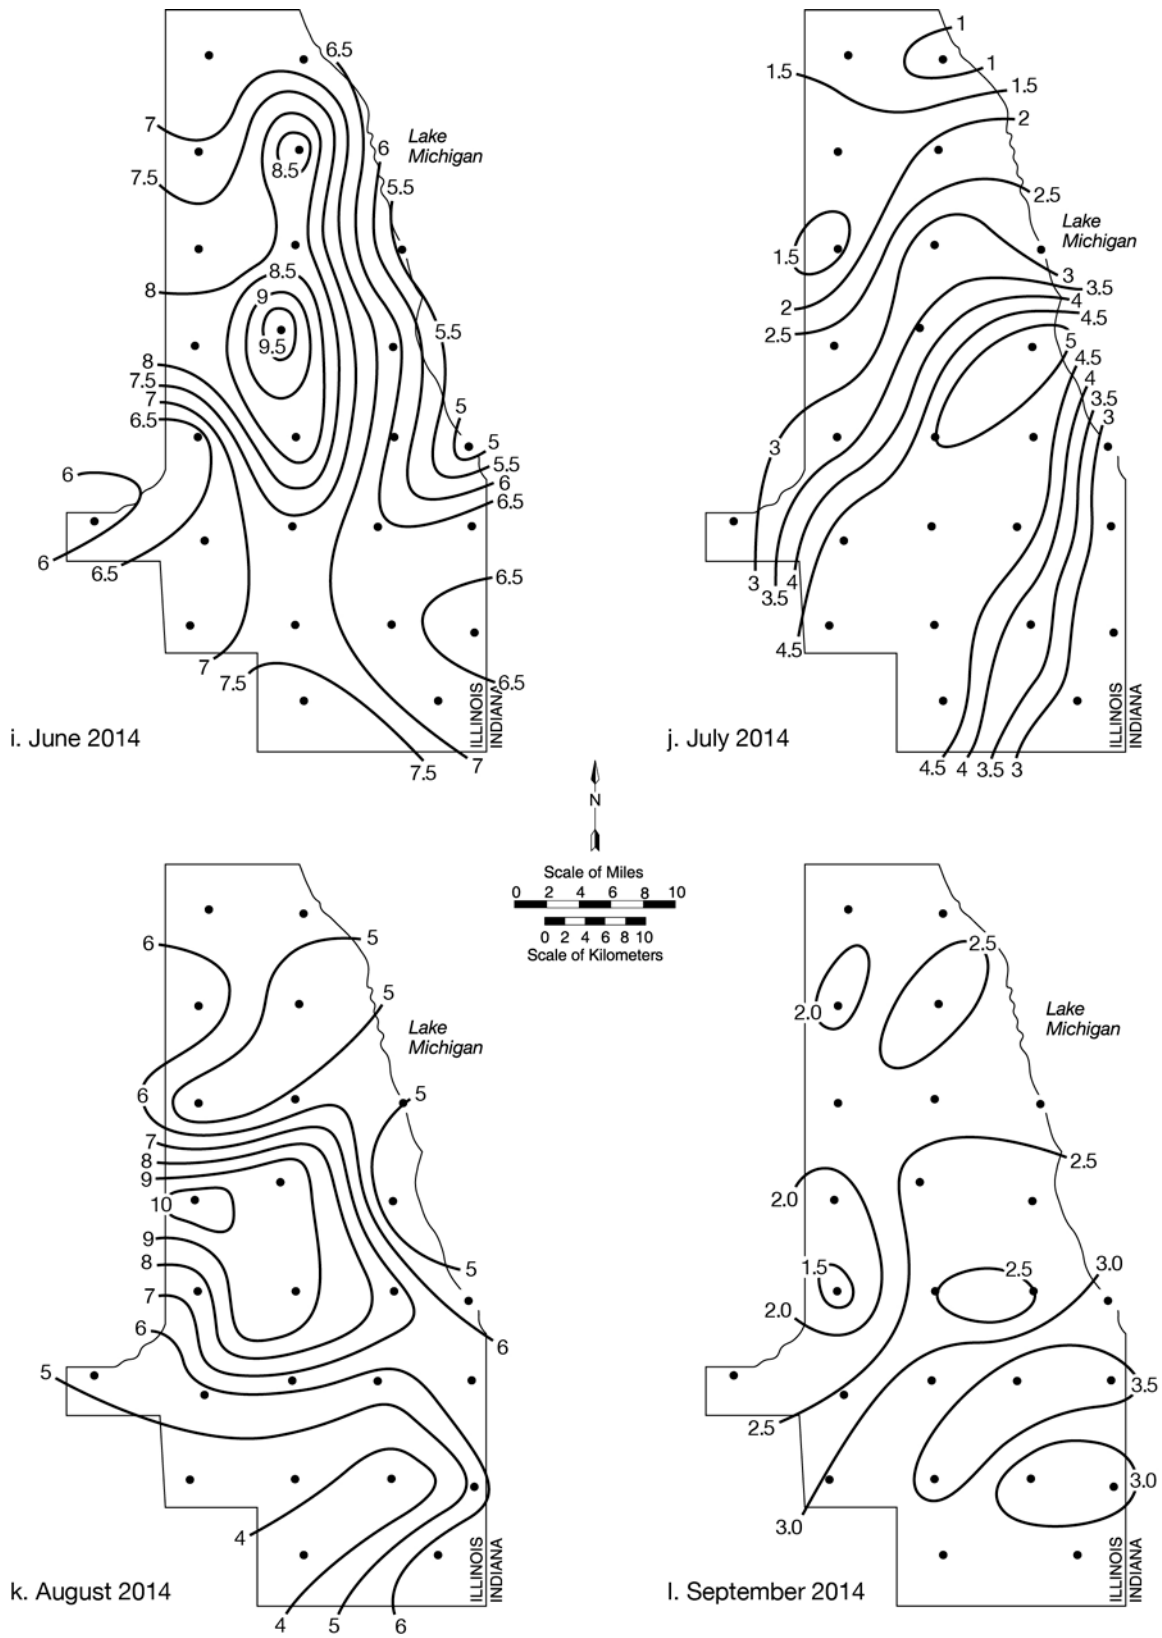
Figure 5. Precipitation pattern (inches) for October 2013–September 2014

Figure 5 presents monthly precipitation patterns for Water Year 2014. The June 2014 network precipitation of 6.98 inches was 161 percent of the 24-year June average precipitation. Monthly network precipitation amounts were 66 percent of the 24-year average in December 2013 and March 2014. During the other months, network amounts ranged from 79 to 144 percent of normal. Less than 2.0 inches of precipitation fell in December 2013 and March 2014. More than 4.0 inches of precipitation fell in October, May, June, and August 2014. From October 2013 through August 2014, there were two storm events that exceeded a network average of more than 2.0 inches with at least one individual gage amount of more than 4.0 inches, on October 30-31, 2013 and on August 21-22, 2014.
